UNITED STATES ENVIRONMENTAL PROTECTION AGENCY

Re: Draft Spring 2012 Bank Conditions Monitoring Report for the Former Plainwell Impoundment and Plainwell No. 2 Dam Area at the Allied Paper, Inc./Portage Creek/Kalamazoo River Superfund Site (August 2012)

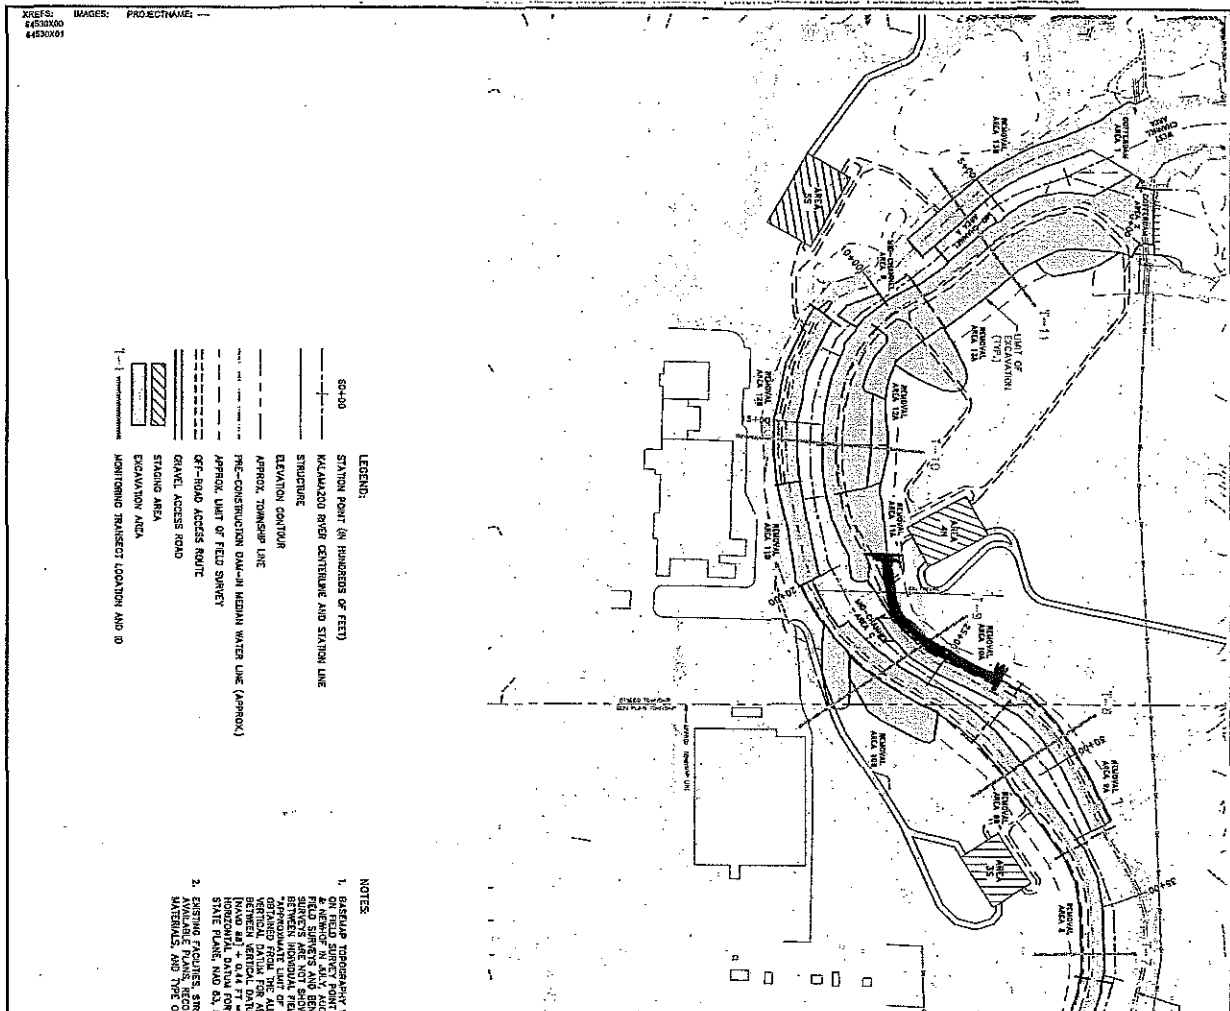
ATTACHMENT: Preliminary Sketch RA 10a, Area where rock should be installed to prevent erosion.

1. No significant issues of concern were identified upstream of US 131.
2. a) We observed some areas of continuing erosion in the former Plainwell Impoundment area that are between the US 131 bridge and the pipeline crossing that should be treated with rock. Specifically, RA 6B and 10A need to be addressed. These areas do not have stable banks and continue to erode. Given the constricted stream channel width, it is necessary to provide continuous rock protection along the water line and up the slope to the bankfull elevation (2-Year Storm Water Elevation). In addition, Georgia Pacific, LLC (Georgia Pacific) must replace the rock cover at RA 10B since we observed exposed liner in RA 10B during the joint visit on August 30, 2012.

To help in the planning process, we have attached a preliminary sketch for RA 10a. The sketch indicates that new rock will be placed beginning at a point upstream of the pipeline crossing, where the design rock terminates, to a point downstream of the pipeline crossing. The exact area will need to be confirmed in the field by the State, EPA, and Georgia Pacific.

Corrective actions should occur as soon as possible. A stable slope and toe armoring will be necessary. We recommend that willow stakes and other tree or shrub plantings be placed in this reconstructed slope and if necessary, irrigated during July and August and other periods with abnormally dry conditions until the plantings are well established.

Rock used throughout should be appropriately sized and graded river rock or field stone to resist the erosive force.
